BALDERTON LAKE

SURVEY REPORT 2017

BINGHAM SUB AQUA CLUB
SURVEY REPORT OF BALDERTON LAKE
NEW BALDERTON, BALDERTON, NEWARK, NG24 3DF
18th February 2017

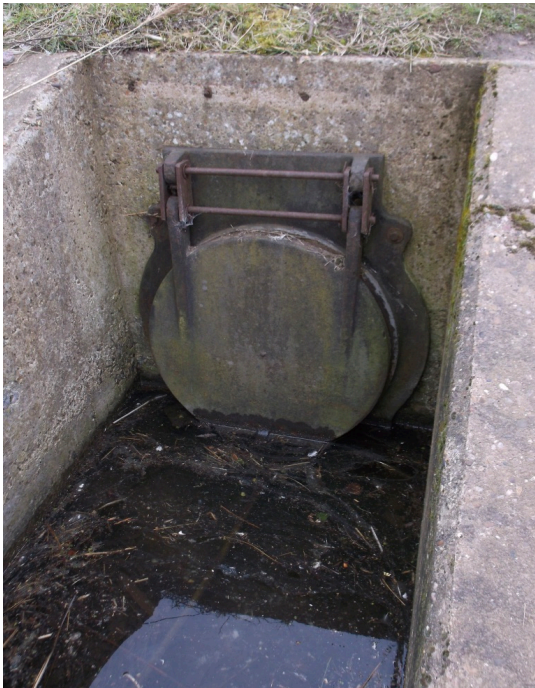
Photo 1 – First water inlet for Balderton lake

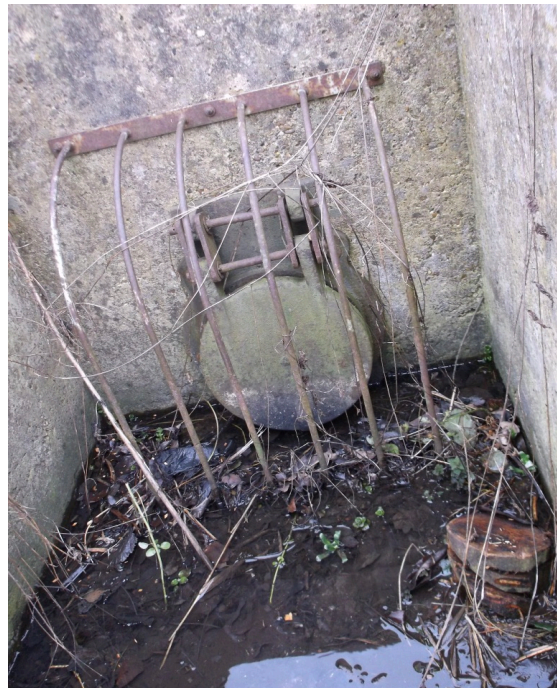
Photo 2 – Second water inlet for Balderton lake

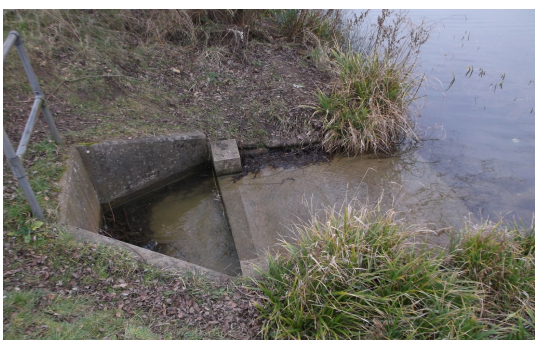
Photo 3 –Water overflow point for Balderton lake

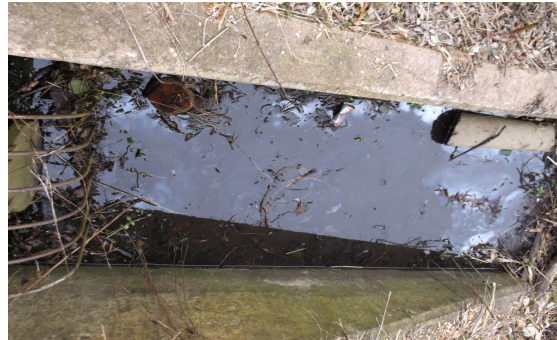
Photo 4 – Contamination from 2nd Inlet

d. The Inlets should be avoided in case of excessive flowing water (this was not evident on both visits). However, there is potential for this to also allow for contamination as was evident in photo 4 above.

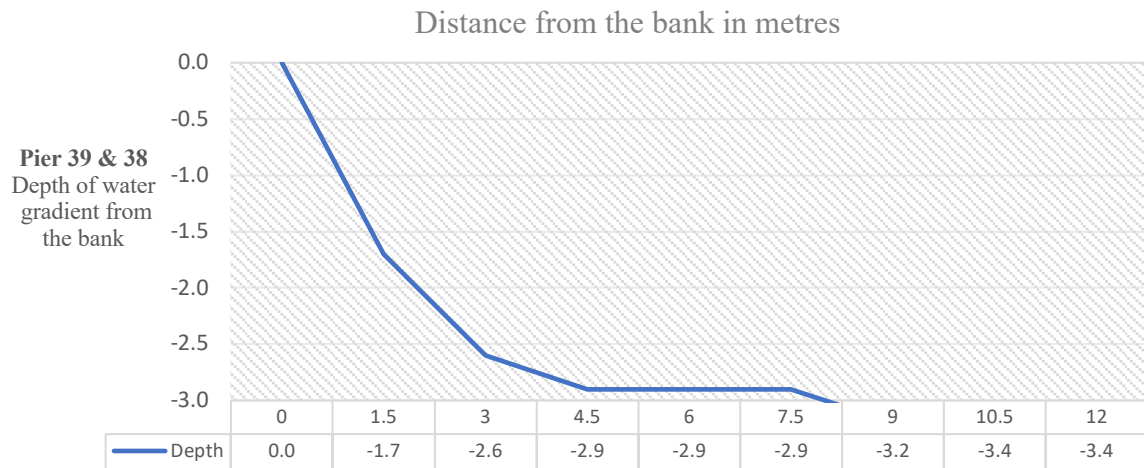
7.1 The steepest drop off is located between fishing pier 39 and 38 to the southerly side of the lake. This was measured to understand the distance to depth ratio, as you can see from the chart below this area at the southerly side of the lake between fishing pier 39 & 38 has the severest drop off with it reaching 1.7metres in depth within the first 1.5 meters in distance from the shore. The remainder assessed have fairly shallow drop offs in comparison. A comprehensive brief on this is contained in the appendix 2 and in the Newark dive club brief at appendix 3. However, there is some discrepancy in the fishing pier numbers from the Newark dive club brief. I believe these may have changed numbers since 1992. However, the depths remain fairly consistent. If a further investigation of this is required, it can be done at a later date.

Chart 1 – Depth to distance ratio from shore

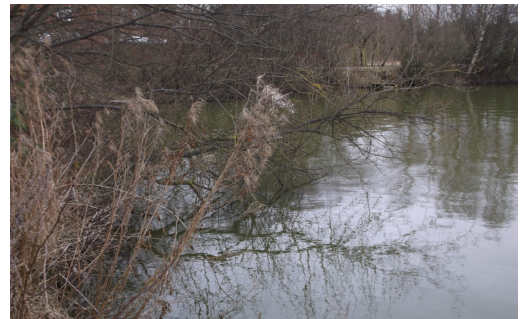
a. Overhanging trees were identified around the bank in a variety of places around the lake. These could cause entrapment if accessed from the water, but could also be avoided if required, as they are easily seen.

Photo 6–Overhanging tree Balderton lake

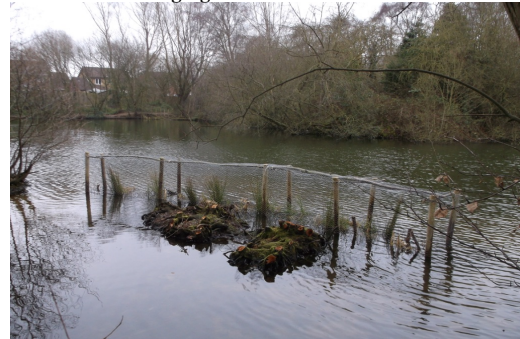
Photo 7–Reef Construction Balderton lake

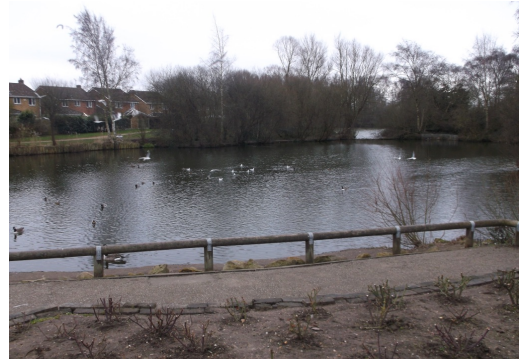
c. The Pump pond is a natural reserve protected from access lake by a man-made barrier and floating island. The majority of the bird life of the lake is congregated around this area and in our opinion should be avoided by all other users. This is due to the potential risks caused by bird faeces and the potential damage to the lake environmental ecological system.

Photo 8–Pump Pond Balderton lake

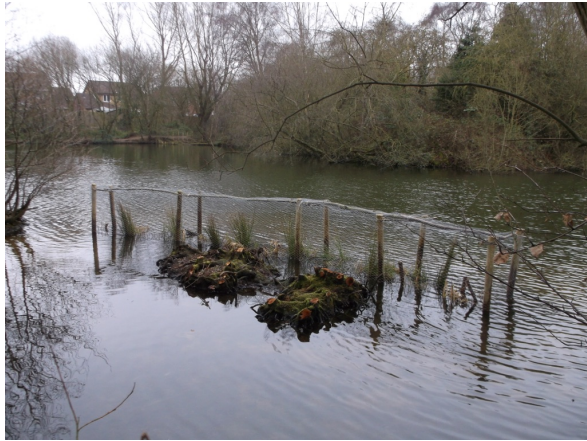
9. **Reef Construction and Floating islands;** The Clean rivers trust report (2014) discusses the development of the site with the use of large blocks of concrete that may have been placed into the lake to create feeding sites and allow for algal growth and zoo plankton development. We believe some of these sites can be seen close to banks of the lake as they have been built up above the water level, and reeds and other wetland plants can be seen growing out of them. The floating islands believed to have been sunk by vandalism could not be found, however local fisherman believe one of them is 50-60 meters directly North of fishing pier 34. When we scanned this site with the sonar there was a small increase in height but no more than 0.1 metre, as shown in picture 11. However, on the sonar it did pick up a growth of reeds surrounding this sight. Suggesting it may well have created a small reef. This sight was dived on the first trip and due to the visibility, nothing was found. This could be due to the nature of the lake bed at this point being soft mud, so it is assumed that the floating island may well have partially sunk beneath the mud. To verify this a further survey would need out be carried out.

Photo 9 – Raised Reef/Reed beds

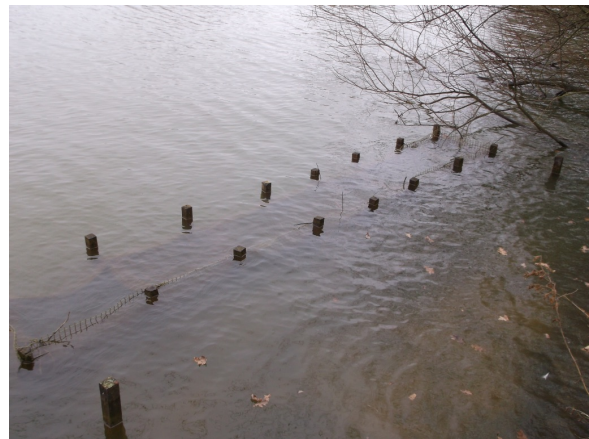
b. Evidence of reef construction can be seen alongside the shore line; these areas are identified by stakes with mess protecting a reed bed. These should be avoided to protect them. There is one identified without mesh (Picture 10 below) on the western side of the lake close to the shore line. This provides a hazard as wooden spikes are protruding out of the water, these can be avoided by staying away from this part of the shore line or placing a seclusion zone around his area.

Photo 10 – Unprotected unused reef/ reed bed.

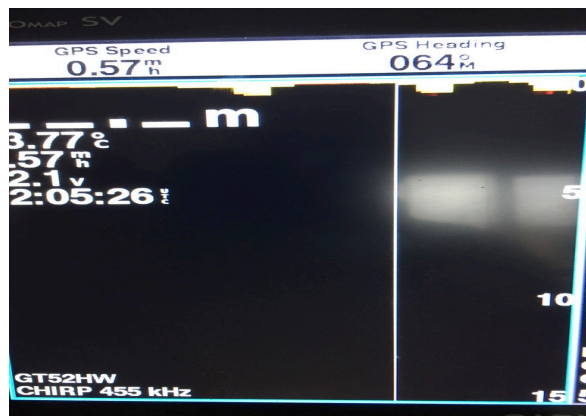
8. **Hazards;** A systematic search was carried out across the entire lake and no significant hazards were identified beneath the water surface using the sonar detector. The only detection was an area where we identified a rise in height from the lake bed of no more than 0.3 metre (1 ft.) these were deemed insignificant and a possible explanation of this is mention in point 9 below.

Photo 11–Sonar reading Balderton lake

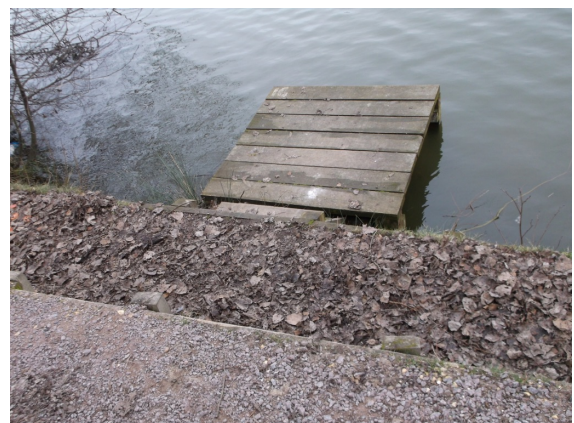
e. There is easy access into the water from the fishing piers and no formal protection to stop someone slipping into the water. The fishing piers are made of wood and care should be taken if wet as you could easily slip into the water.

- f. Rotten wooden piers, there are a few fishing piers identified that need to be repaired or isolated so that no one uses' them due to broken, missing, rotten or damaged slats.
- g. There were a number of fishing lines and lead weights discarded around the lake, which create hazards to the wildlife and fish. The majority were seen in and around the trees on the shore line.

Photo 12–Fishing Pier Balderton lake
